EXECUTIVE SUMMARY

Stephen F. Austin Elementary is over 60 years old and most systems require upgrade or replacement. Accessibility and security is lacking throughout the school. There are several ADA compliance issues, including restroom areas. The building's mechanical and electrical systems are in need of replacement. The life safety system is in need of upgrading. The site parking, roads, site access and handicapped compliant access to the play areas are non compliant. The security of the site at the main entry and multiple classroom wings provide uncontrolled points of entry that compromise the security of the facility.

401 N. GULF BLVD.

FREEPORT, TX 77541

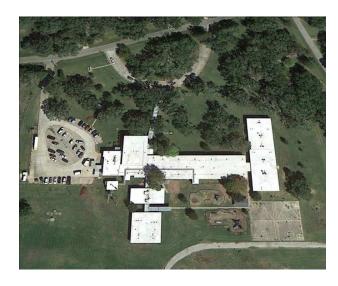
General Notes:
Site Conditions	
Parking & Drives	Concrete parking, and asphalt drive
Sidewalks	Minimal sidewalks, none connect to doors,not accessible.
ADA Accessibility	Non-compliant entry ramp & site circulation . No HC parking
Site Signage	No directional site signage. HC sign at parking. Marquee
Playground Areas	
Condition	Play area in fair condition. Not accessible.
Accessibility	Not accessible, needs ramp
Athletic Areas	Basketball court in fair condition, minimal cracks, damaged
Landscaping/Irrigation	Several ponding water locations
Utilities & Drainage	Ponding water in multiple areas
Dumpster Service Area	within staff parking lot. Not screened.
Site Lighting	Non-uniform lighting at firelane, Minimal lighting typ.
Security	No fencing around site. No security vestibule at entry
Chain Link Fencing	No overall site fencing. Req'd for site security
Ornamental Fencing	No fencing. Req'd for site security

, ,	
	Maintenance Cycle	1	Condition			Special Notes	
	Schedule		or			or	
	Years		Qua	-,			Observations
Site work		1	2 3	4	5	N/A	
On-Site Utilities & Drainage							Ponding water in multiple areas
Site Drainage / Erosion Control							Ponding water, bar ditch at entry for drainage
Storm Sewer Line							<u> </u>
Sanitary Sewer Line							
Water Supply Line / Sprinkler Supply Line							
Gas Line							Exposed gas line
Electric Service Line / Phone Line							low hung power lines
Site Lighting- Building and Parking Lots							Site lighting uneven across drive/parking, canopy lights exist
Exterior Concrete Pads & Pavement- Around building , mechanical yards							Entry paving is good, asphalt road, concrete parking/fire lane
Fire Hydrants / Utility Vaults / Misc.							
Landscape & Irrigation							Several ponding water locations
Topsoil and finished grading condition							
Grass and Sod condition	-

Trees / Plants / Shrubs / Ground Cover / Vines							Trees overhang fire lane and roof
Landscape Maintenance				T			Grasses growing in gutters, not maintained
Site Irrigation System			-		干		
	· 	\vdash	_		+	H	
Site Parking & Drives							Concrete parking, and asphalt drive
Roads / Drives / Parking Areas		П	\top	Т			Cracking/decomp asphalt and water ponding @ staff parking.
Fire Lanes			+	П	_		Concrete fire lane. Non-uniform lighting around fire lane
Parking lot and fire lane stripping		\vdash	+	Ë			Parking striping Illegible
Traffic - Parking Control / Misc. Site Equipment		\vdash	+		10		Inadequate visitor parking, all parallel spots
Curbs		\vdash	-		۳		Poured-in-place curb on 1 side of drive, vehicle stop on other side
Curbs	· ———	\vdash	ᆛ	_		+	1 oured-in-place curb on 1 side of drive, verificie stop on other side
							Minimal side wells, were connect to do so not connected
Sidewalks		_	_	1-			Minimal sidewalks, none connect to doors,not accessible.

Sidewalks / Steps / Ramps		\vdash	_		-	_	Cracking, uneven sidewalks.
Court Yards / Patios / Misc. Paving							-
							B. L. H. H
Outdoor Athletic Areas				_			Basketball court in fair condition, minimal cracks, damaged goals
Play Fields		$\perp \perp$			_	_	Asphalt running track with some ponding
Tennis Courts							
Hard court play areas							1/2" offset around paving not accessible. Minimal cracking
Backstops							Basketball backboards cracking w/poles in fair condition
						Ш	
Playgrounds							Play area in fair condition. Not accessible.
Play areas						Ш	Open playground
Playground access for handicapped				1		Ш	Not accessible, needs ramp
Playground equipment						Ш	
Playground base material] _			Decomposed mulch with grass growing. Base lining decomposing.

Maintenance Cycle Condition			Special Notes			
	Schedule	Schedule or			or		
	Years		Qualit	у			Observations
Miscellaneous Exterior Site Items							
Site Lighting							n-uniform lighting at firelane, Minimal lighting typ.
Site Security						No	fencing around site. No security vestibule at entry
Cameras						Nor	ne evident.
Chain Link Fencing / Gates						No	overall site fencing. Req'd for site security
Ornamental Fencing / Gates						No	fencing. Req'd for site security
Misc. Structures							
Site Walls -Retaining / Screen					[No	retaining/screen walls.
Dumpster Service Area						with	hin staff parking lot. Not screened.
Site Signage- Directional / Handicapped						No	directional site signage. HC sign at parking. Marquee sign good.
Site Furniture / Specialties						Rus	sting and bent picnic tables
Misc. Site work / Recreational / Site Structures					[
ADA Compliance/Accessibility						Nor	n-compliant entry ramp & site circulation . No HC parking

Compliant Sidewalks/Curbs						Not	t compliant. Sidewalks do not extend to doors.
Compliant Ramps & Handrails						No	ramps on property.
HC & Van Accessible Parking Spaces						No	handicapped accessible parking
Accessible routes from HC parking, Bus drop off & mass transit to front door						Nor	ne available
			Ш				
Average Site Grade:						4

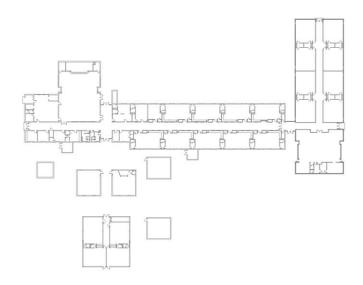
General Notes:
Exterior Building Condition	
Exterior Envelope	
Wall Condition	no weepholes in brick @ some locs. Brick control joints pulling apart
Window Condition	Deteriorating condition. Clouded glazing & mildewy sealant
Doors/Entrances	Fair
Secure Entrance	No security vestibule
Farradation /Streeture	No visible cracks on exterior, no foundation settling
Foundation/Structure	noticeable
Roofing Areas	Single ply is in poor condition and should be replaced
Existing Warranty	No warranties remaining
Area for repair	None
Area for Replacement	All single ply areas
Exterior Building	Sitelighting uneven at firelane, Minimal lighting in parking
Lighting	areas
Kitchen dock/loading	4" paving at delivery entrance, 3" bump in concrete not
entry	ideal for deliv.
Comonico	Some damage on posts, conduits running on surface of
Canopies	canopies
Additional information	Moldy, warped exterior building fascia at perimeter of
Additional information	building.

_					
	Maintenance Cycle	cle Condition					Special Notes
	Schedule						ОГ
	Years		Qua				Observations
Building Structure/Foundation	· ·	1 :	2 3	_	5	N/A	No visible cracks on exterior, no foundation settling noticeable
Foundation							
Piers / Caissons / Piles / Footings							
Grade Beams							Cracking in concrete grade beam evident at Building Addition
Foundation Walls							
Special Foundation / Misc.							
Substructure - Slab - on - Grade							
Basement / Below Grade Exterior Walls	_						
Interior Slab on Grade							Uneven floor slab at Library entry (1979 Addition)
Entry Steps / Ramp / Porch Slabs							Cracking at entry slab
Sub-base - For All Bldg. Slabs							
Special Substructure / Misc.							
Superstructure							
Suspended Floor / Mezzanine / Roof / Column Systems							
Interior Structural / Shear Walls	-						
Fireproofing				1			Unknown if present on structure.
Structural Steel							
Misc. Steel			1

Concrete frame under super structure							
Pre-Engineered Metal building							Rusting & damaged walls/roof at exterior mech. room
Stairs & Miscellaneous structures							
Stairs & Ramp Structures	-						
Platform & Catwalk Structures							
Misc. Attached Structures -Canopy / Porch / Rooftop							Bent canopy columns at entry. Rusting canopy roof deck
Misc. Steel -Structural Framing / Bracing			1				
Misc. Wood -Blocking / Framing / Rough Carpentry -Exterior			1				
Expansion Joints			1				
Building Exterior Shell	T	h	1	1	Ħ	\neg	
Roofing							Single ply is in poor condition and should be replaced
Roof Covering							Single ply is in poor condition and should be replaced
Traffic / Pavement Toppings							Single ply is in poor condition and should be replaced
Roof Insulation & Fill							Insultion values do not meet current code requirements
Roofing Sheet Metal	-						Sheet metal needs to be replaced
Skylights	-

Maintenance Cycle	Maintenance Cycle Condition		Special Notes	
	Schedule	or			or
	Years	Quality			Observations
Exterior Walls	100.0	Ĭ	uunty		no weepholes in brick @ some locs. Brick control joints pulling apart
Exterior Wall Face & Back-Up Construction- Brick				Т	Weep holes missing at some brick. Control its pulling apart.
Exterior Wall Face & Back-Up Construction- Plaster					
Exterior Load Bearing Walls					
Exterior Balcony Walls / Railings					
Exterior Louvers / Sunscreens					
Exterior Painting			[3	CMU Walls uniformly painted. Peeling paint at soffits/fascias.
Windows/Glazed Walls					Deteriorating condition. Clouded glazing & mildewy sealant @ some
Windows					Single hung aluminum casement, single pane windows
Curtain Walls					
Exterior Doors	·				Fair
Exterior Storefront / Entry Walls			[]	
Exterior Storefront / Entry Doors			[]	Wiring visible at top of entry doors (at interior)
Exterior Doors					Interior door used for exterior condition at gym exit.

Exterior Overhead / Rolling Doors					
Exterior Hardware			0		
Exterior Door Panic Hardware					
Weather/Waterproofing					Poor and needing maintenance.
Waterproofing					No evidence of leaking from interior of building.
Caulking / Sealants				1	Brick control joint caulking falling out. Mildewy sealant @ windows
Exterior Soffits					Unevenly painted. Mildew and Peeling paint at fascias
Finishes To Misc. Exterior Structures					Adequately sealed at connection bet. canopies & building
Miscellaneous Exterior Building Items					
Canopies					Some damage on posts, conduits running on surface of canopies
Freestanding Canopies				_	Some rusting at canopy deck. Bent supports @ canopy at entry drive
Canopies attached to building					
Exterior Building Lighting			E	_	Sitelighting uneven at firelane, Minimal lighting in parking areas
Secure Front Entry					No security vestibule
Kitchen Dock/Loading Zones		+]	4" paving at delivery entrance, 3" bump in concrete not ideal for deliv.

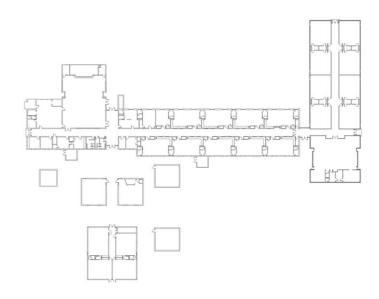
INTERIOR BUILDING AREAS	
Circulation:	No security vestibule at entry.
Interior signage:	Signage at classrooms and restrooms.
	ADA compliant.
Layout:	Double loaded corridors. 5th, 6th, and Art/Music are located separately from main building.

General Notes:
Interior Building Areas	
Classrooms	Double-loaded corridors. Shared restrooms between classrooms.
SPED Classrooms	Not a specialized classroom and Not accessible.
Science Labs	No Science Labs present.
Computer Labs	2 computer labs. Area does not meet TEA standards. Some computers located w/i Classrms
Art/Music	Classrooms located in satellite buildings.
Library	Inadequate space for reading & presentations. There is no place to put presentation screen.
Cafeteria	Serves as Cafeteria and Gym with stage, folding tables
Kitchen/Serving	Not accessible, tables in cafet. for condiments
Gymnasium	Serves as Gym and Cafeteria with stage
Auditorium	Shares space with Gym and cafeteria
Administration	Limited circulation for visitor check-in.
Staff Work Areas	Limited circulation.
Clinic

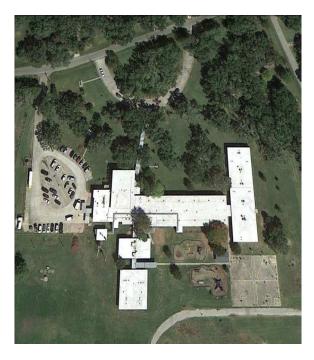
General Notes:
Interior Building Cond	ition
Ceilings	Fair Overall Condition
Floors	VCT & carpet. Some VCT pulling apart (possible slab heaving)
Interior Wall	VCT & carpet floors, CMU & gyp bd wall finish, ACT on
Finishes	ceiling.
Millwork	Mostly wood w/plastic laminate(PLAM) and is chipping or cracked.
Restrooms	Student restrooms in fair condition, not accessible.
Food Service Areas	Contains both functional & outdated equipment. Showing wear.
Doors and	Wood doors/frames and hollow metal frames. HW not
Hardware	compliant.
ADA Compliance	Water fntain, classroom sinks/RR, most door hardware-not ADA

Maintenance Cycle	Conc	lition		Special Notes
	Schedule	0	r		or
	Years	Qua			Observations
nterior Building Conditions		1 2 3	3 4	5 N/A	
Interior Building Finishes					Mostly acoustic ceiling tiles (ACT), no evidence of roof leaks
Ceilings				\bot	Fair Overall Condition
Acoustical Ceilings					Main act ceiling installed below original 12x12 ACT glued to furring
Ceiling Grid Condition				\bot	90 degree grid, fair condition
2 x4 or 2 x 2 tiles - condition and type			١	\bot	2x4 and 2x2 acoustic foam
Vinyl Coated or Other type installed in grid system					
Plaster Ceilings					
Drywall Ceiling			١		
Metal Ceilings					
Exposed / Painted Ceilings					
Soffit / Bulkhead Walls					
Special Ceilings / Soundproofing / Misc.					
Floors			1		VCT & carpet. Some VCT pulling apart (possible slab heaving)
Carpeting			1		Mostly in fair condition, needs minor treatment (6' wide rolled)
Resilient Flooring - VCT					Some areas are pitted, some fair VCT. Some pulling apart of tiles

Pavers / Slate / Marble					
Quarry Tile					
Ceramic Tile					Ceramic tile at shared RRs. Cracking within grout. Dirty grout.
Wood Flooring					
Terrazzo Floor / Special Composition					
Finish Concrete - (sealed)					
Stair Finishes					
Special Flooring / Misc Raised Access Flooring					
Interior Wall Finishes			1		VCT & carpet floors, CMU & gyp bd wall finish, ACT on ceiling.
Interior Partition Construction			1		Painted CMU (original building) & painted gyp bd (1979 Addition)
Wall Studs at interior columns					Unknown condition
Glazed block & CMU corridor			1		Mostly CMU throughout original building
Gypsum board at interior column furrings					within1979 Addition
Tape, Bed, Texture, & Paint interior column furrings					within1979 Addition
Studs insulation at interior face of exterior wall					Unknown condition
Gypsum board at interior face of exterior wall					within 1979 Addition
Tape, Bed, Texture, & Paint interior face of exterior wall					within 1979 Addition

1	-	
	Maintenance Cycle	Condition	Special Notes	
	Schedule	or	Or Observations	
Interior Balcony Railings	Years	Quality	Observations	
Wall Surface Finishes & Veneers		┪	Mostly painted CMU or brick. Elec. conduits on face of brick/CMU	П
Demountable / Folding / Office Partitions		 		<u>. </u>
Interior Louvers / Soundproofing / Misc.		+++		
Interior Wall Base & Trim		 		
			Openings in walls closed with brick/boarded up or patched w/CMI	11.1
Misc. Finishes			Mostly wood w/plastic laminate(PLAM) and is chipping or cracked	
Millwork Cabinets			iviosity wood w/plastic laminate(PLAW) and is chipping of cracked	u.
Display Cases			Manager and Control of the Control o	
Marker Boards			Masonite used for dry erase on top of old chalkboard	
Building Directory				
Corner Guards				
Lockers				
Mail Boxes				
Interior Signage / Graphics -ADA Graphics			Classroom & public RR signage. No direction signage	
Base Building Graphics & Signage

Interior Finish Graphics & Signage				
A/V Equipment				
A/V Projection Screens			Using white boards as screen	
Interior Window Blinds			Most blinds are bent.	
Loading Dock Equipment			1	
Digital clocks			1	
Wireless access				
Conveying Systems			No conveying systems	
Freight Elevators			-	-
Cab Finishes			-	-
Passenger Elevators			1	
Cab Finishes			-	
Dumbwaiters / Lifts				
overall Restroom Condition & Finishes			Student restrooms in fair condition, not accessible.	-
Restroom Walls	T		Tiled floor to ceiling in public RR, exposed CMU in student RR	
Restroom Ceilings		- - - -	Mostly acoustic ceiling tile(ACT) in fair condition	
Restroom Fixtures		 		
Toilet Partitions		 	Plastic partitions in public RR, Glazed brick partition in student RF	R
Toilet Accessories		╅╬┼┼	Student restroom accessories in fair condition	
ADA accessibility	_	- 	Public restrooms are accessible, student restrooms are not.	
, i.e., i. dococommity		- 	- ability restriction are accessible, stadent restricting are not.

Maintenance Cycle	С	onditi	ion		Special Notes
	Schedule		or			or
	Years	(Quali	ty		Observations
Equipment						Equipment is functional and in fair/good condition.
Serving lines						Components are outdated and no water service is provided.
Dish return area						Functional but aged & showing wear.
Dry storage pantry						Addition with cooler, exposed wiring
Food freezer and refrigerator						No walk-in freezer. Cooler is aged & showing wear.
Exhaust Hood						Fully functional
Flooring material and base						Tile flooring. Aged & showing wear.
Ceiling material						ACT. Aged & showing wear.
Wall Material and finish						Painted CMU/brick and glazed brick. Aged & showing wear.
Staff restroom						Not ADA code compliant.
Separate Locker room						Not present.
Food Service Office						Not present. Desk located in Kitchen/prep space.
Interior Doors & Hardware						Wood doors/frames and hollow metal frames. HW not compliant.

Interior Storefront / Glazed Walls / Borrow Lites						·
Interior Storefront / Entry Doors						Exposed wiring at entry storefront
Interior Doors (including frames)						wood & laminate doors. Wood & hollow metal frames.
Interior Overhead / Rolling Doors & Grilles						
Special Doors						
Interior Hardware						Not accessible
Interior Door Panic Hardware						
Interior Wall Base & Trim / Cabinets / Misc. Finishes						Mostly intact with some wear/chipping
terior ADA Compliance & Accessibility						Water fntain, classroom sinks/RR, most door hardwarenot ADA
Restrooms - Fixtures & Accessories						Student restrooms are not accessible.
Drinking Fountains						Not accessible
Interior Ramps						
Interior Signage						Door number signage with braille. Public RR has accessible signage.
Interior Doors and Hardware						Most door hardware is not accessible
Millwork/Fixed Workspaces						Millwork at accessible height, sinks don't have clear space below

Other?						
CM Materials						ACM present.
Presence of ACM Materials suspected?						
uilding Code Requirements						Unknown building code used.
Building code requirements met?						Unknown at this time
Energy code requirements met?						Unknown at this time.
Fire code requirements met?						No sprinklers.
