O.M. ROBERTS ELEMENTARY

EXECUTIVE SUMMARY

Floor Plans

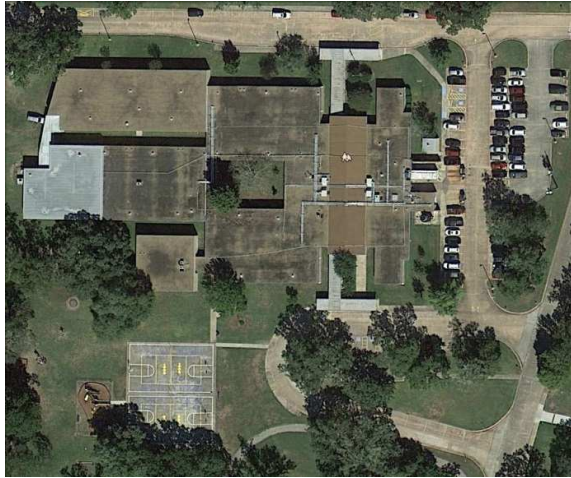
Special Notes or Observations
Some flooding- utilities unknown at this time
Parking lot and outdoor walkways flood. Some water enters bldg.
Inadequate lighting at parking lots.
Fire hydrants located at side parking near street
Minimal landscape; mature trees; no irrigation
Grass appears in good/fair shape - a few spots are worn to sod. Many mature trees on site.
Not applicable.
Inadequate visitor parking
Needs restriping
Restriping needed.
Sidewalks are in fair condition.
Athletic areas are in fair condition Security fencing needed
(4) backboards and goals in good condition
Playgrounds have good equipment and fall surface, but are not secure
Accessible equipment with fence around the play area

Maintenance Cycle Schedule Years	Condition or Quality				Special Notes or Observations
Miscellaneous Exterior Site Items						
Site Lighting			<input checked="" type="checkbox"/>			Pole lighting along front drive & at parking
Site Security						No perimeter fencing & admin not @ entry
Cameras			<input checked="" type="checkbox"/>			Cameras are being installed
Chain Link Fencing / Gates					<input checked="" type="checkbox"/>	Chain link fencing only around (2) small play areas
Ornamental Fencing / Gates					<input checked="" type="checkbox"/>	none
Misc. Structures						
Site Walls -Retaining / Screen			<input checked="" type="checkbox"/>			Dumpster area is in the side parking lot with no fencing around.
Dumpster Service Area				<input checked="" type="checkbox"/>		Site signage is minimal - HC signage to be re-painted
Site Signage- Directional / Handicapped				<input checked="" type="checkbox"/>		Minimal site furniture.

Site Furniture / Specialties				<input checked="" type="checkbox"/>		Bike racks in fairly good condition - some rusting
Misc. Site work / Recreational / Site Structures			<input checked="" type="checkbox"/>			ADA accessibility is fair - ramp needed at service dock
ADA Compliance/Accessibility						
Compliant Sidewalks/Curbs			<input checked="" type="checkbox"/>			
Compliant Ramps & Handrails			<input checked="" type="checkbox"/>			
HC & Van Accessible Parking Spaces				<input checked="" type="checkbox"/>		Needs to be re-painted
Accessible routes from HC parking, Bus drop off & mass transit to front door			<input checked="" type="checkbox"/>			
Average Site Grade:						3
